# Manhole Inspection Summary

Manhole # S35AA\_006MH

Insp Date: **11/14/07 8:49 AM**

**Location** Address: **707 n.calvert**

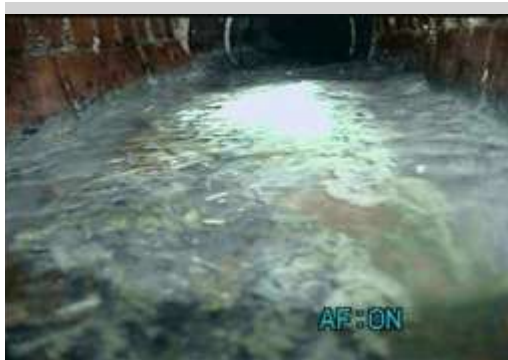
Misc 1

channel debris

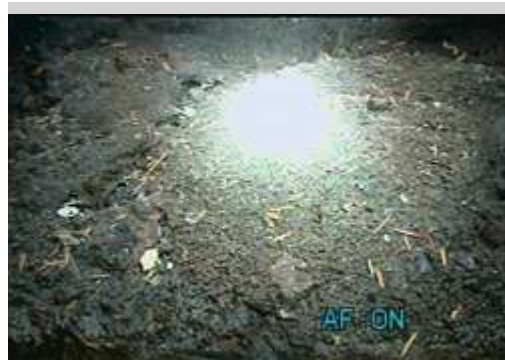
Defect 6

Condition: ☐ Sound ☐ Cracked ☐ Root Intrusion ☐ Deteriorated ☐ Leaks ☒ **Debris**

bench debris

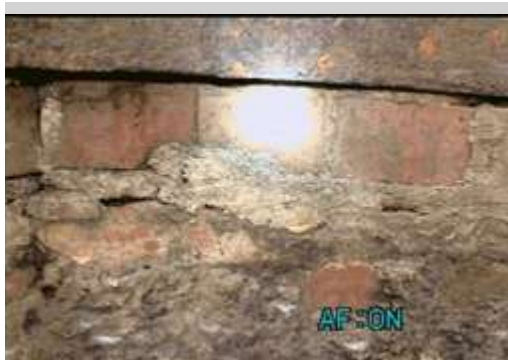
Defect 4

Condition: ☐ Sound ☐ Cracked ☐ Root Intrusion ☐ Loose Brick ☒ **Deteriorated**

chimney\_cond\_deteriorated

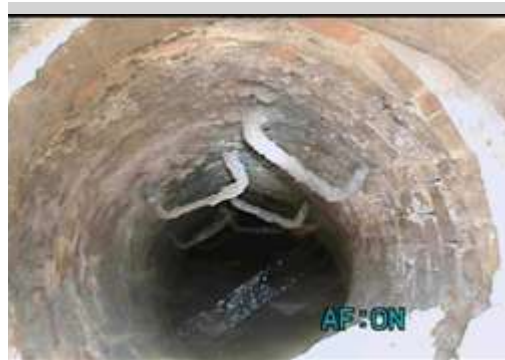
Defect 3

**Steps** Count: **8** Missing: **0** ☒ **Corroded**

steps

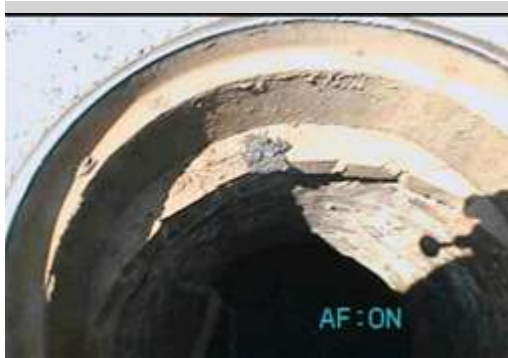
Defect 2

**Frame** Offset: **2** (in.) Condition: ☒ Sound ☐ Cracked ☐ Leaks

frame offset

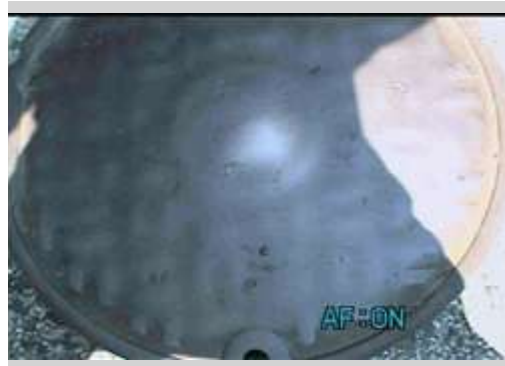
Defect 1

Type: **Sanitary** Condition: **Worn** Cover Material: **Cast Iron**

worn cover
